FLIGHT MEASUREMENTS OF THE FLYING QUALITIES

OF AN F6F-3 AIRPLANE (BUAER NO. 04776)

II - LATERAL AND DIRECTIONAL STABILITY AND CONTROL

MEMORANDUM REPORT

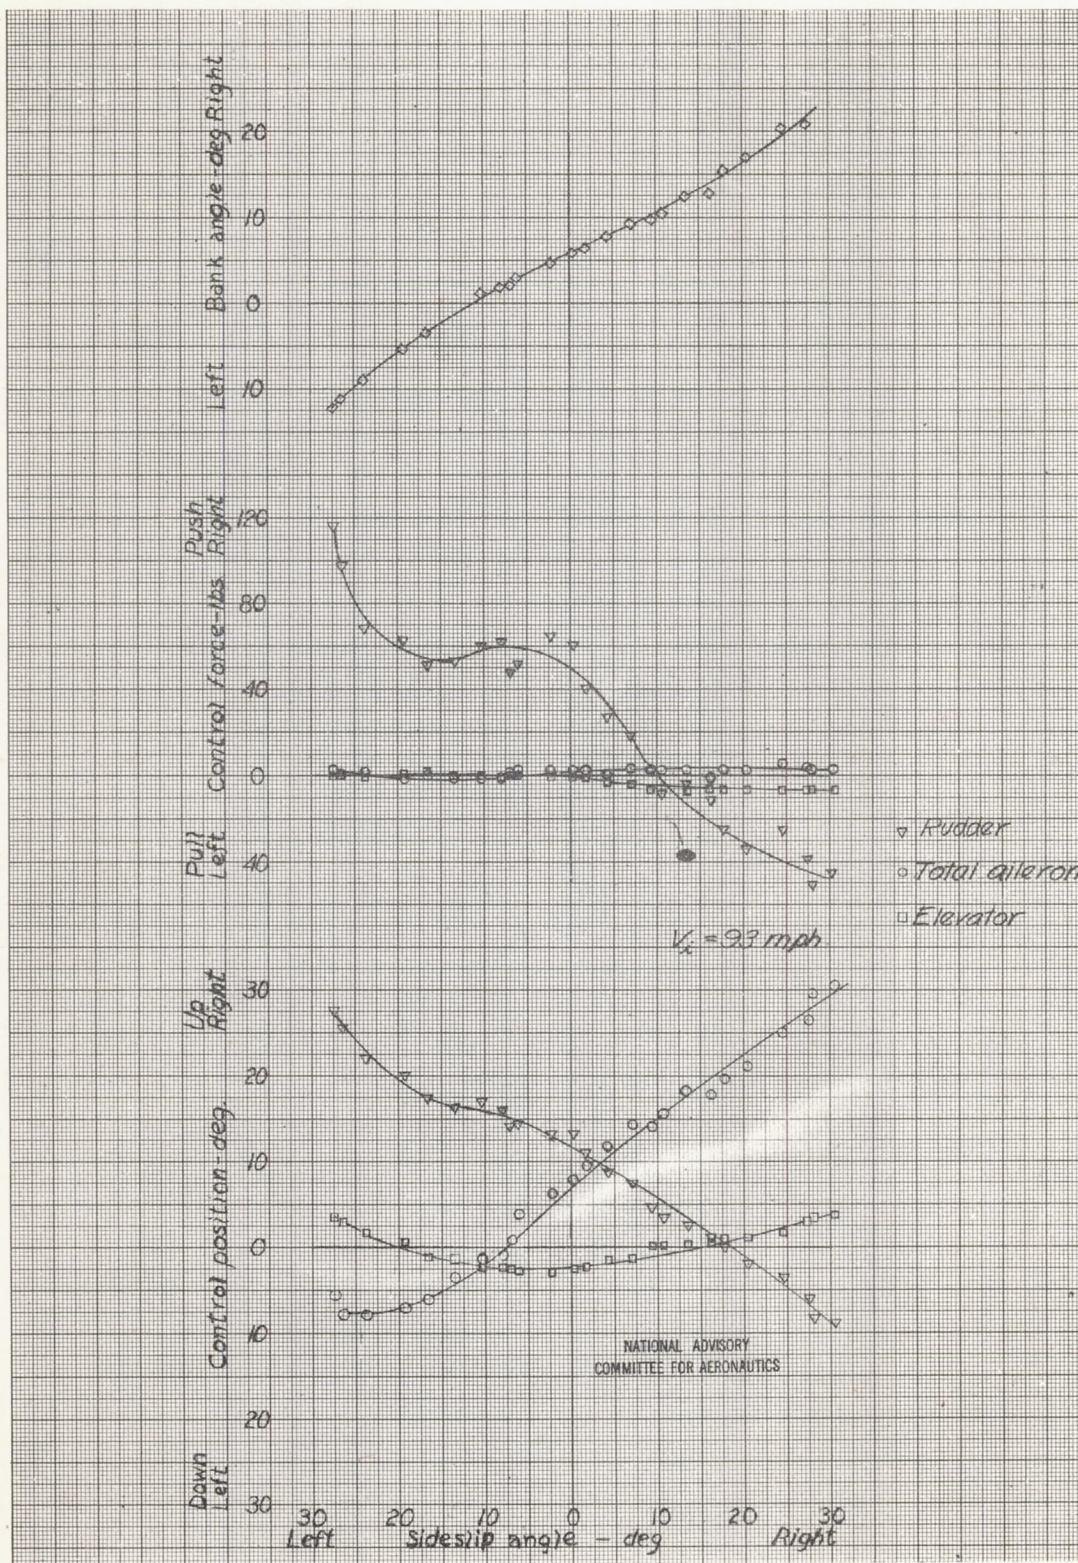
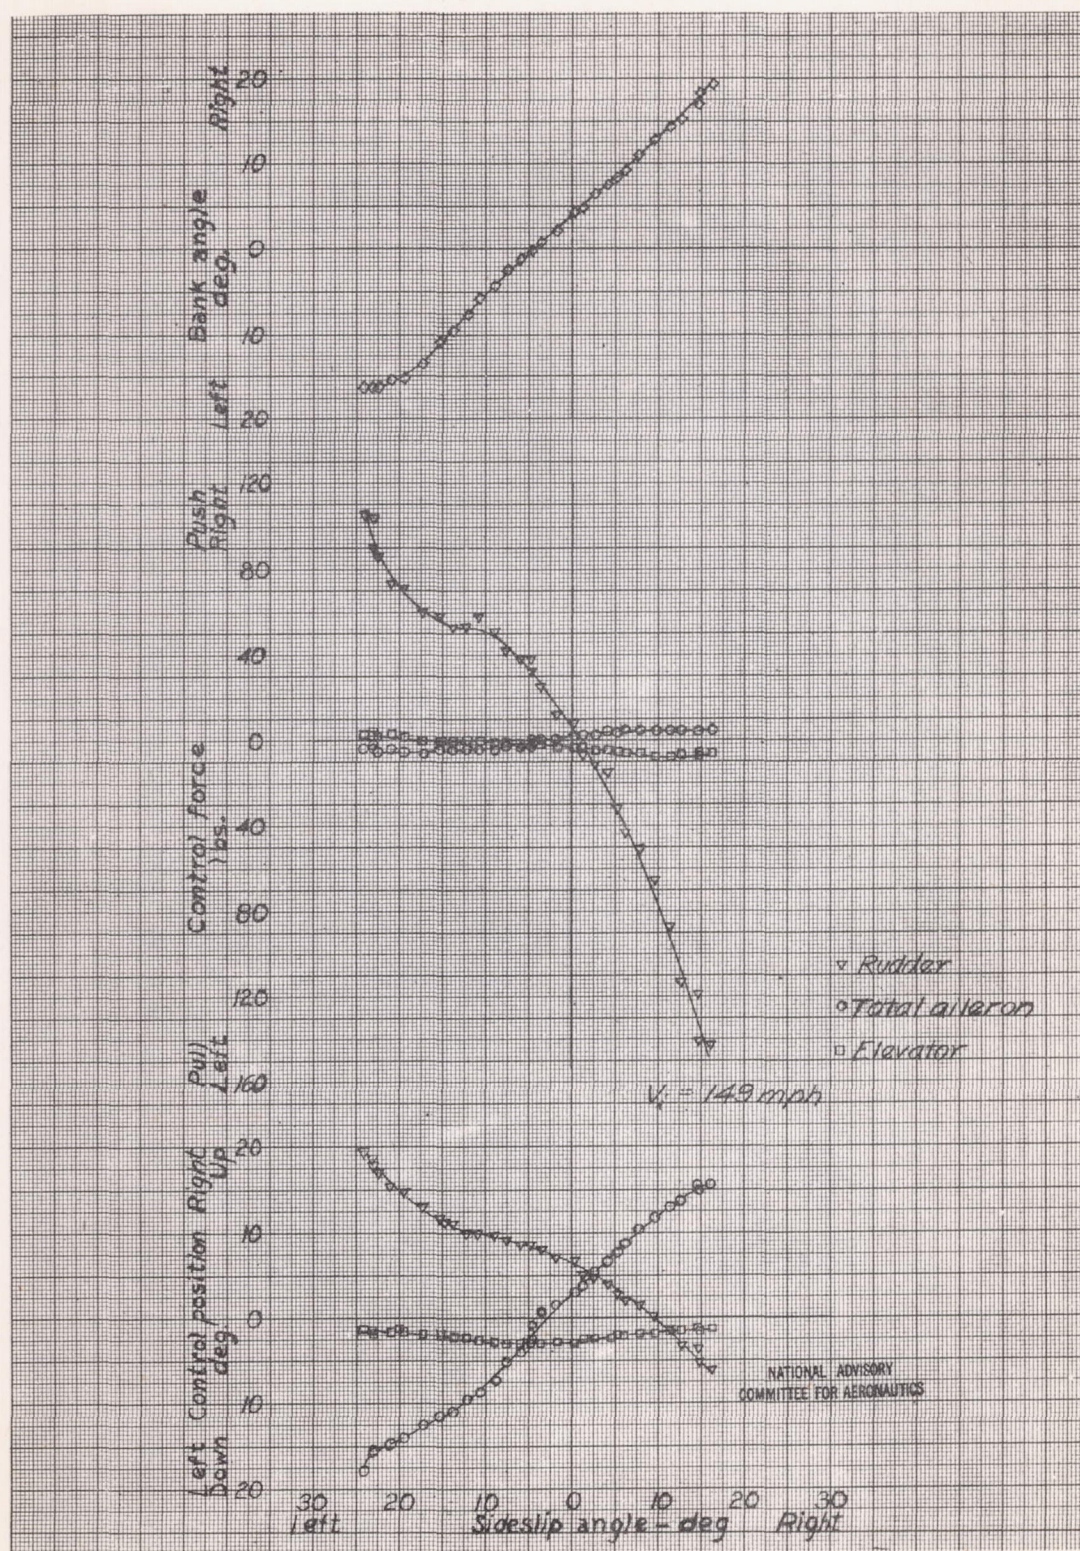
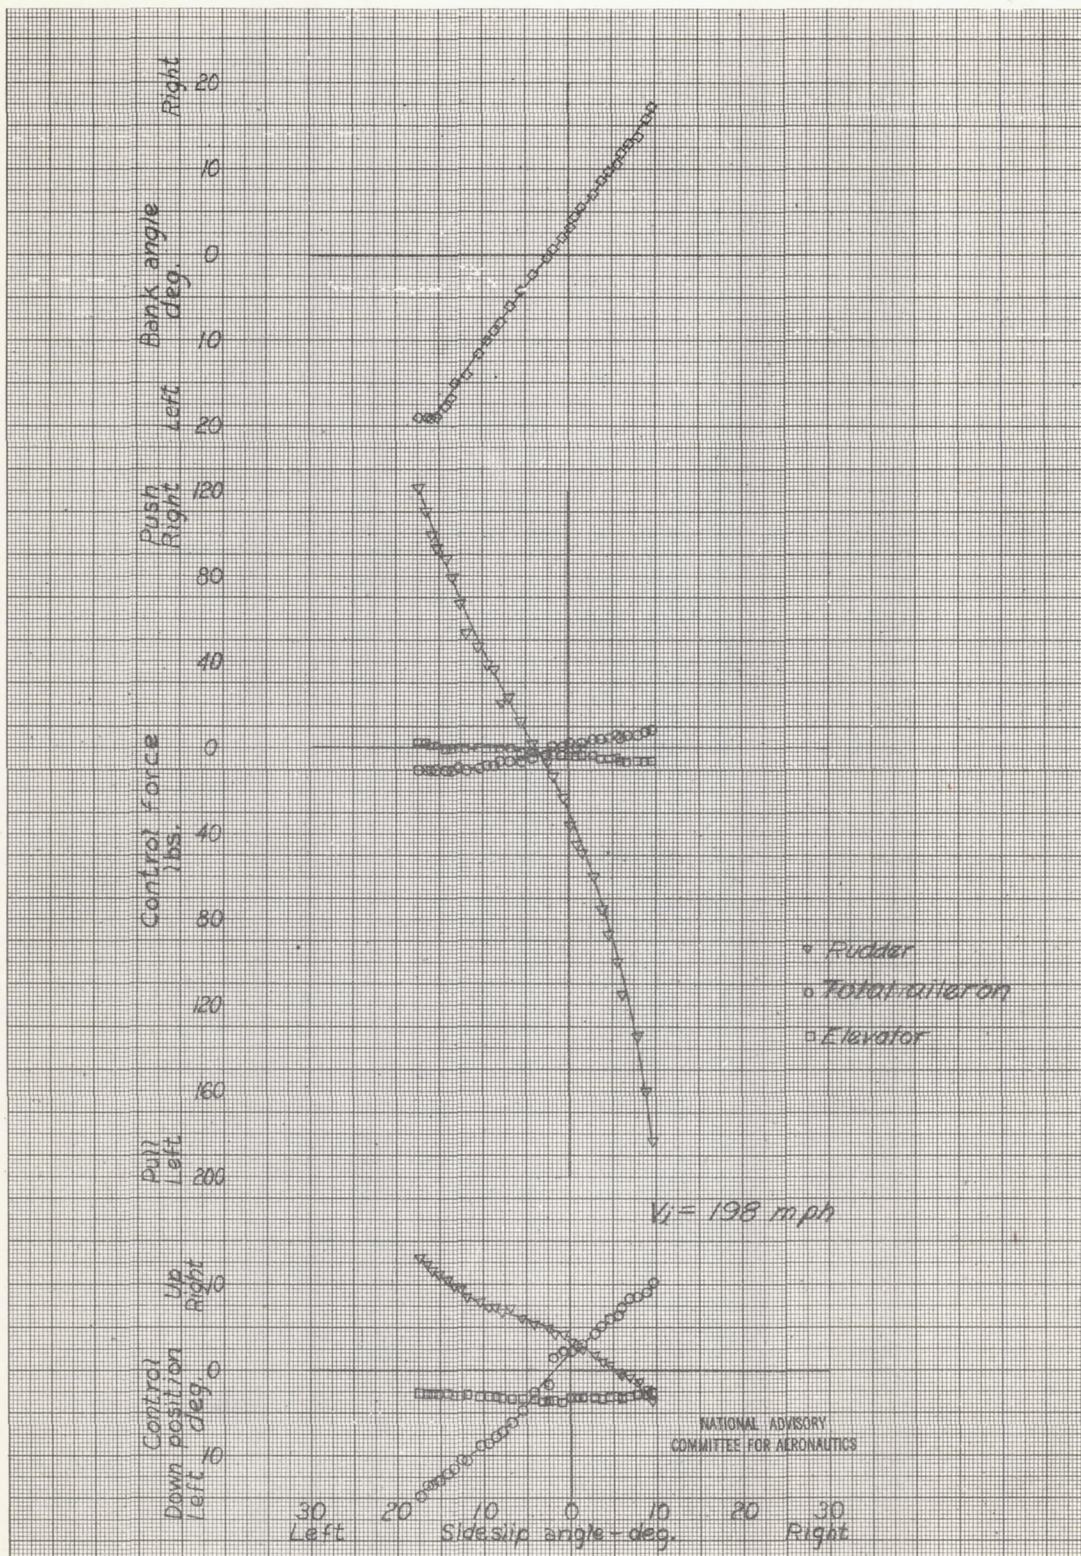
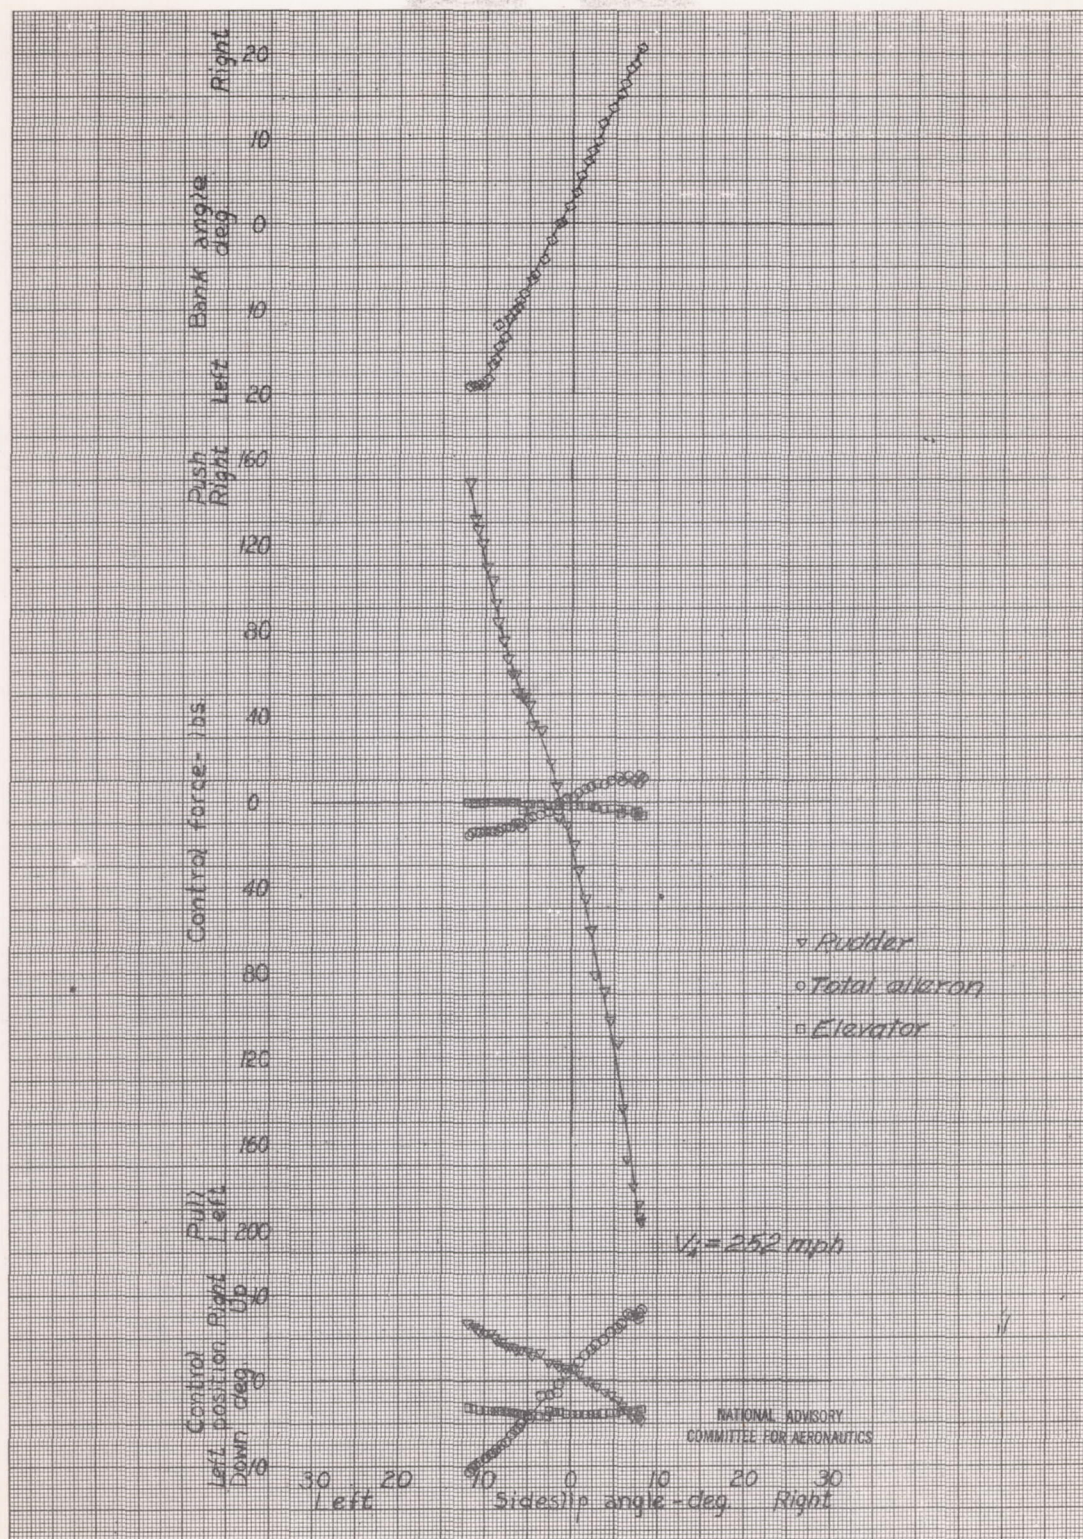
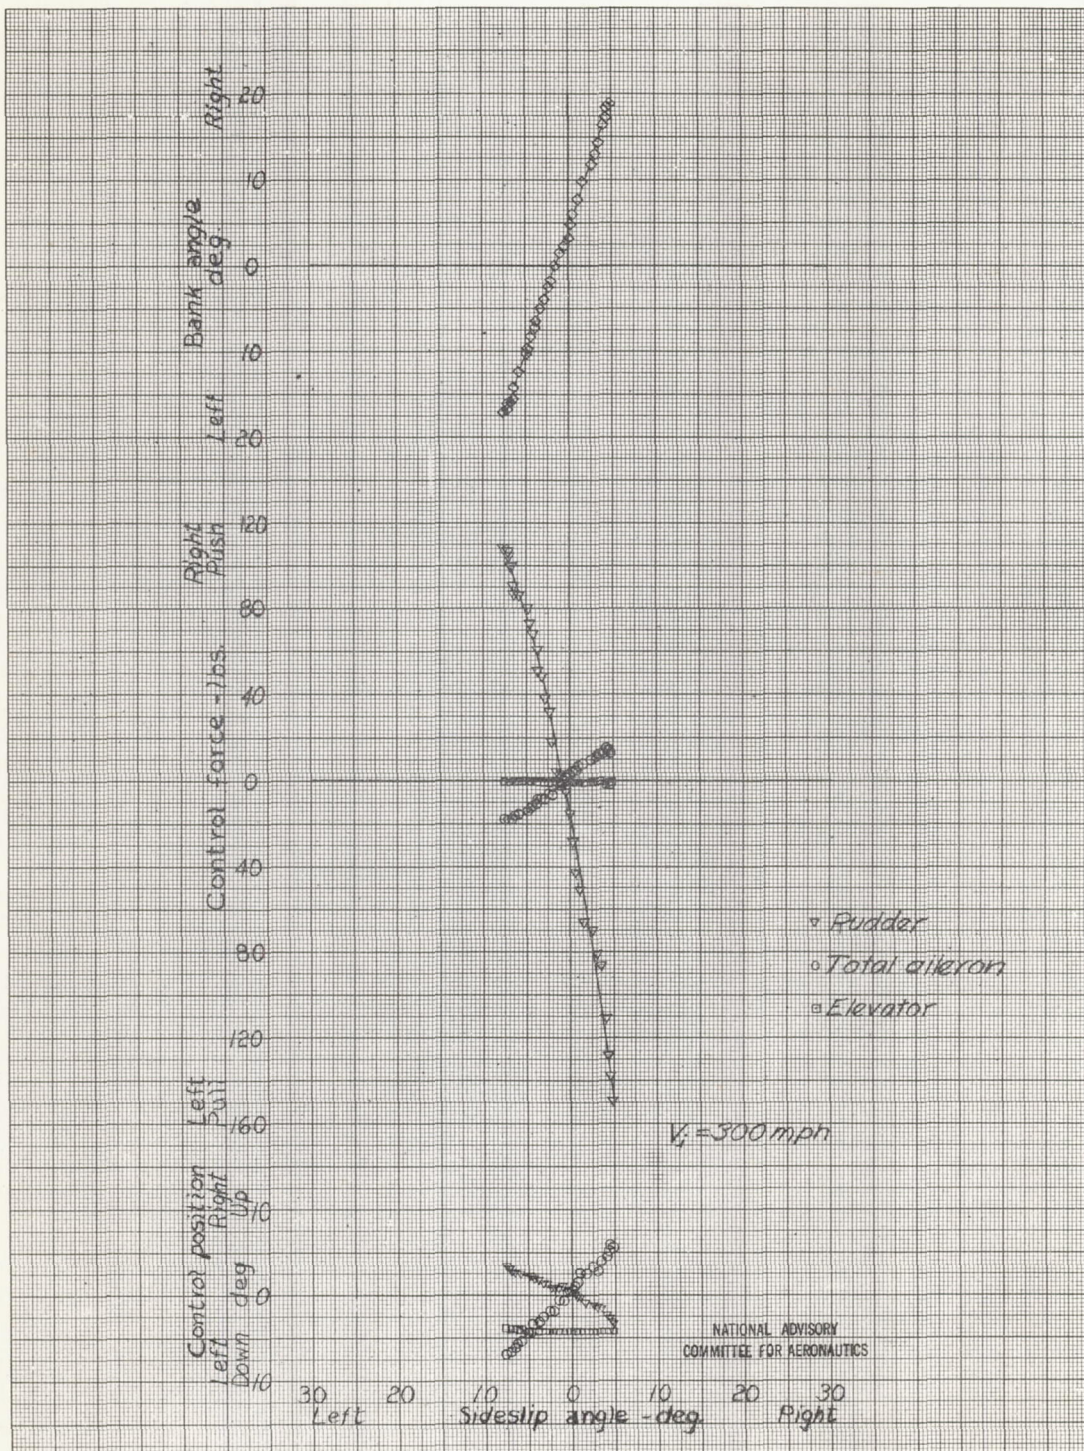
Figure 26. - Steady sideslip characteristics in the climbing condition at 93 miles per hour, F6F-3 airplane.

Figure 27. - Steady sideslip characteristics in the climbing condition at 149 miles per hour, F6F-3 airplane.

Figure 28. - Steady sideslip characteristics in the climbing condition at 198 miles per hour, F6F-3 airplane. -

Figure 29. - Steady sideslip characteristics in the climbing condition at 252 miles per hour, F6F-3 airplane.

Figure 30. - Steady sideslip characteristics in the climbing condition at 300 miles per hour, F6F-3 airplane.

4. As shown by figures 16 to 29 right-rudder force was required to hold right-rudder deflections and left-rudder force was required to hold left-rudder deflections.

The variation of cross-wind force with sideslip angle was in the correct direction; that is, right bank accompanied right sideslip and left bank accompanied left sideslip as shown by figures 17 to 30.

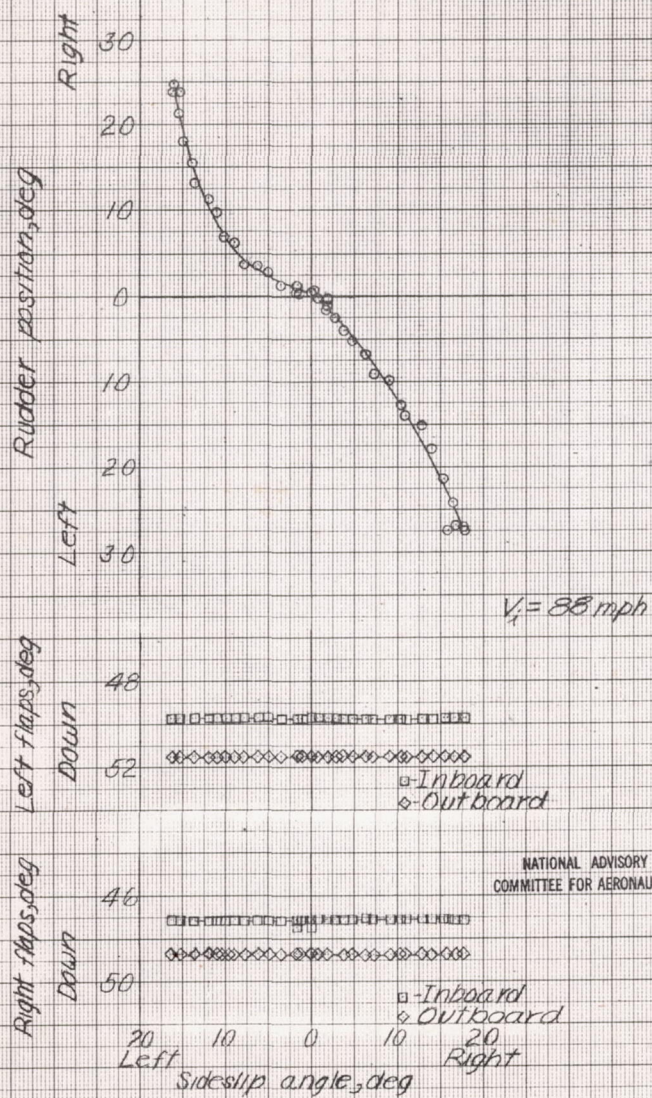
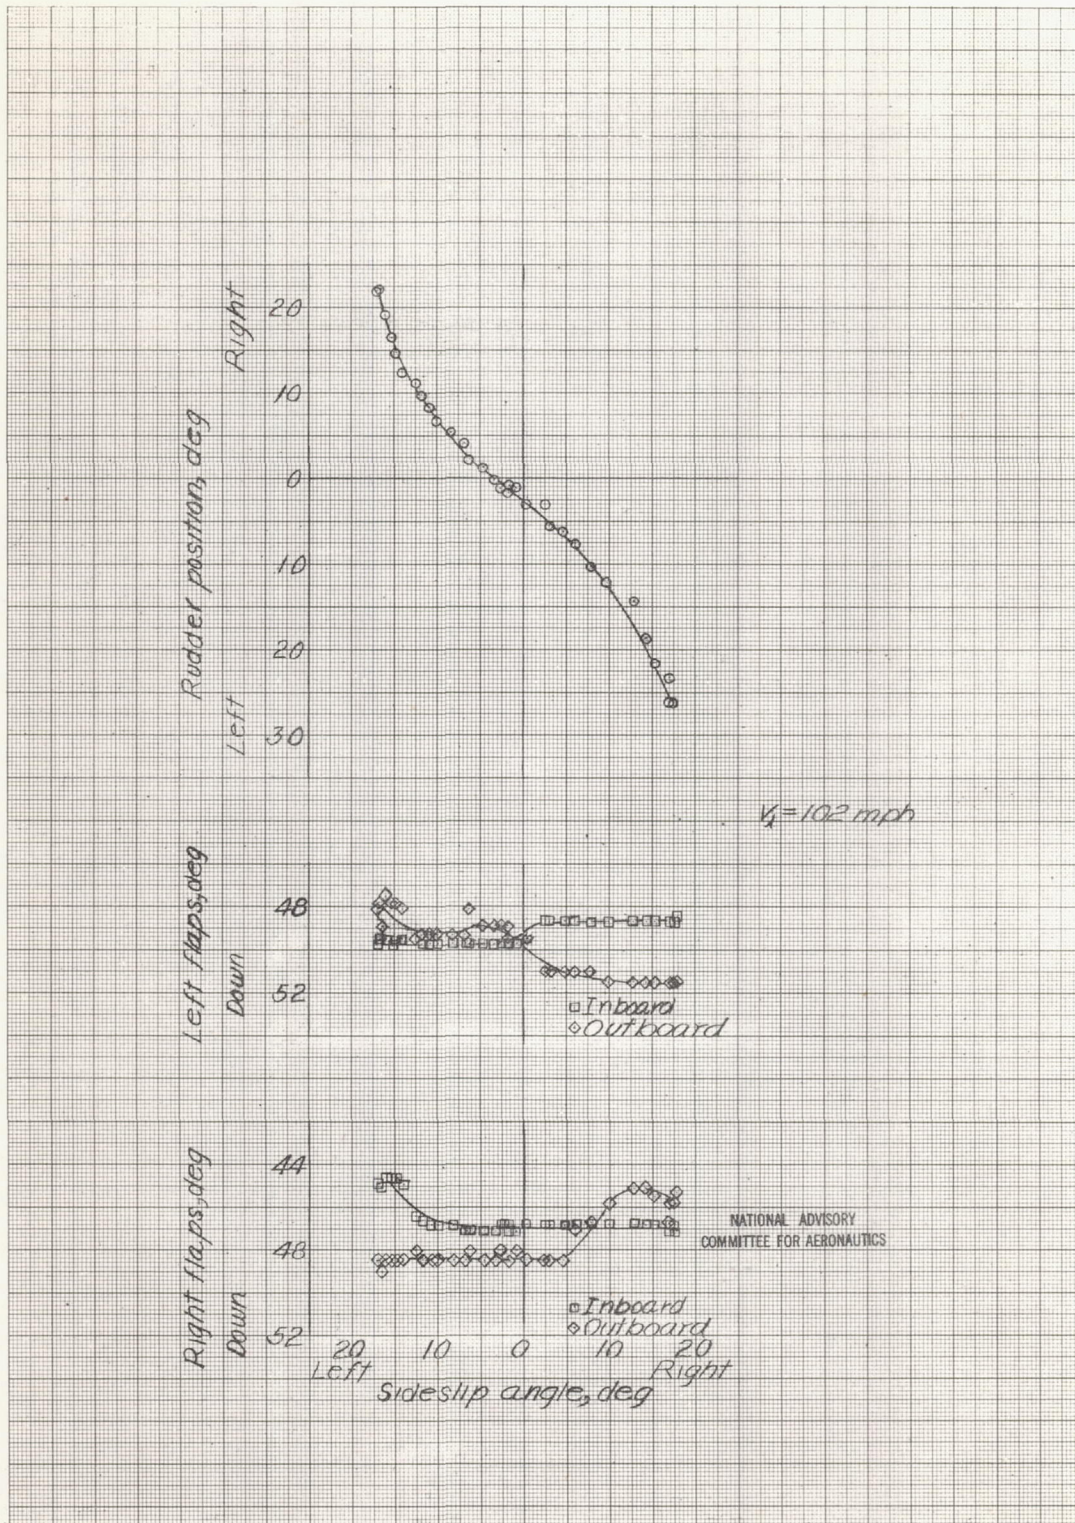
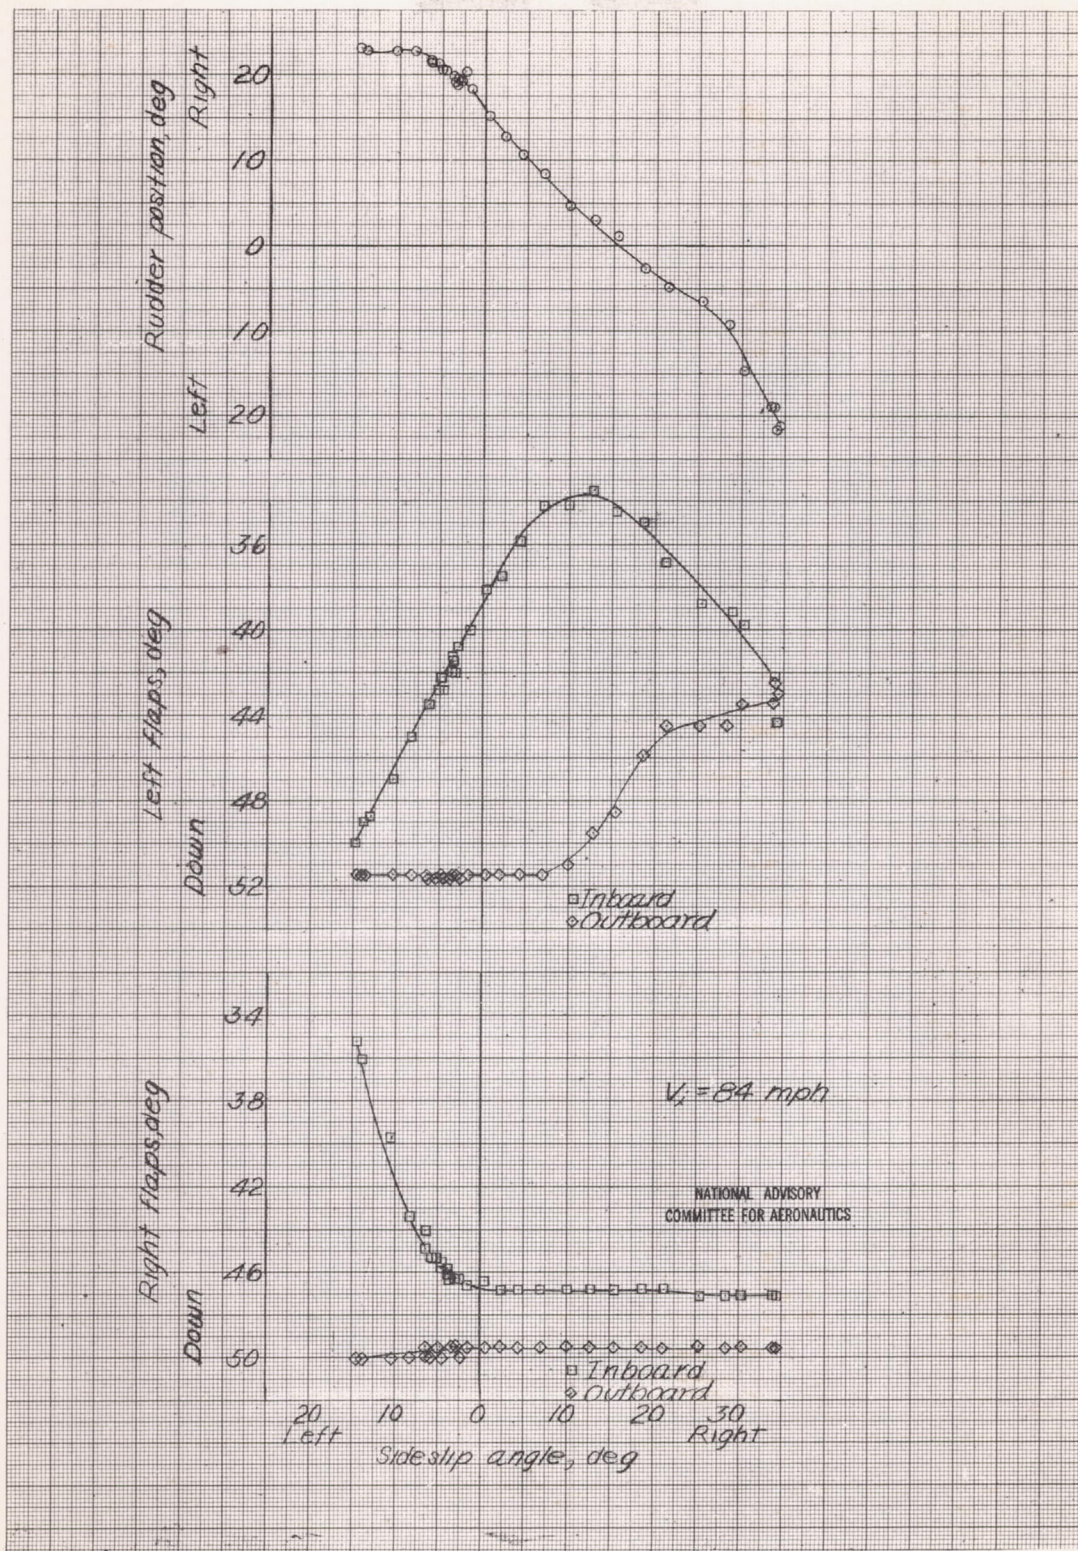
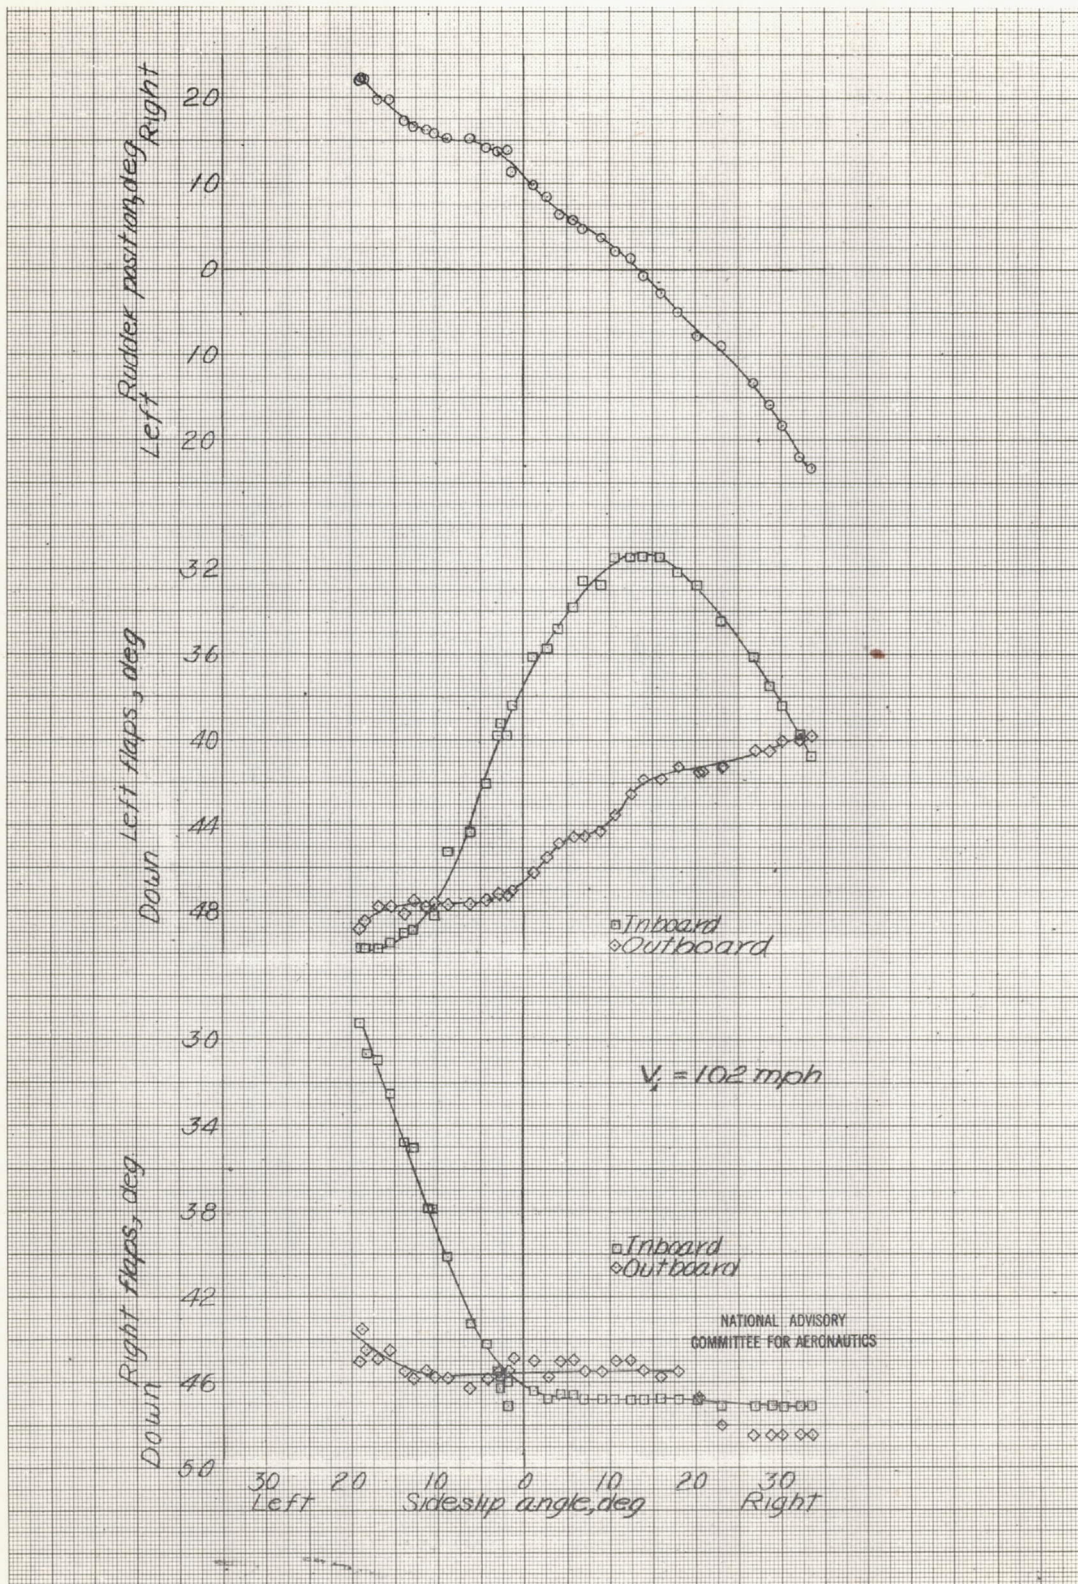
Figure 31. - Flap blow-up characteristics in steady sideslips,
 $V_1 = 88$ miles per hour, landing condition,
 F6F-3 airplane.

Figure 32. - Flap blow-up characteristics in steady sideslips
 $V_L = 102$ miles per hour, landing condition
 F6F-3 airplane.

Figure 33. - Flap blow-up characteristics in steady sideslips
 $V_1 = 84$ miles per hour, wave-off condition,
 F6F-3 airplane.

Figure 34. - Flap blow-up characteristics in steady sideslips
 $V_1 = 102$ miles per hour, F6F-3 airplane.

3. The blow-up characteristics of the landing flaps are such as to cause greater dihedral effect in the wave-off condition than would be obtained if the flaps were held in a fixed full-down position. With flaps that are held rigidly in the down position, dihedral effect is greatly reduced in the wave-off condition because of the additional lift on the trailing wing as the slipstream moves out over the wing with increasing sideslip angle. In the present instance, however, the destabilizing effect is decreased because the flap deflection is reduced by the slipstream over the trailing wing, which decreases the lift on that wing and causes more positive dihedral effect. Unpublished wind-tunnel tests of an F6F-3 model showed that in the wave-off condition at a lift coefficient of 1.46, which corresponds to a speed of approximately 90 miles per hour, the effective

dihedral with the flaps held fixed was 2.6° , while with the flap deflection varying with sideslip angle in the same manner as in the flight tests, the effective dihedral was 3.5° .

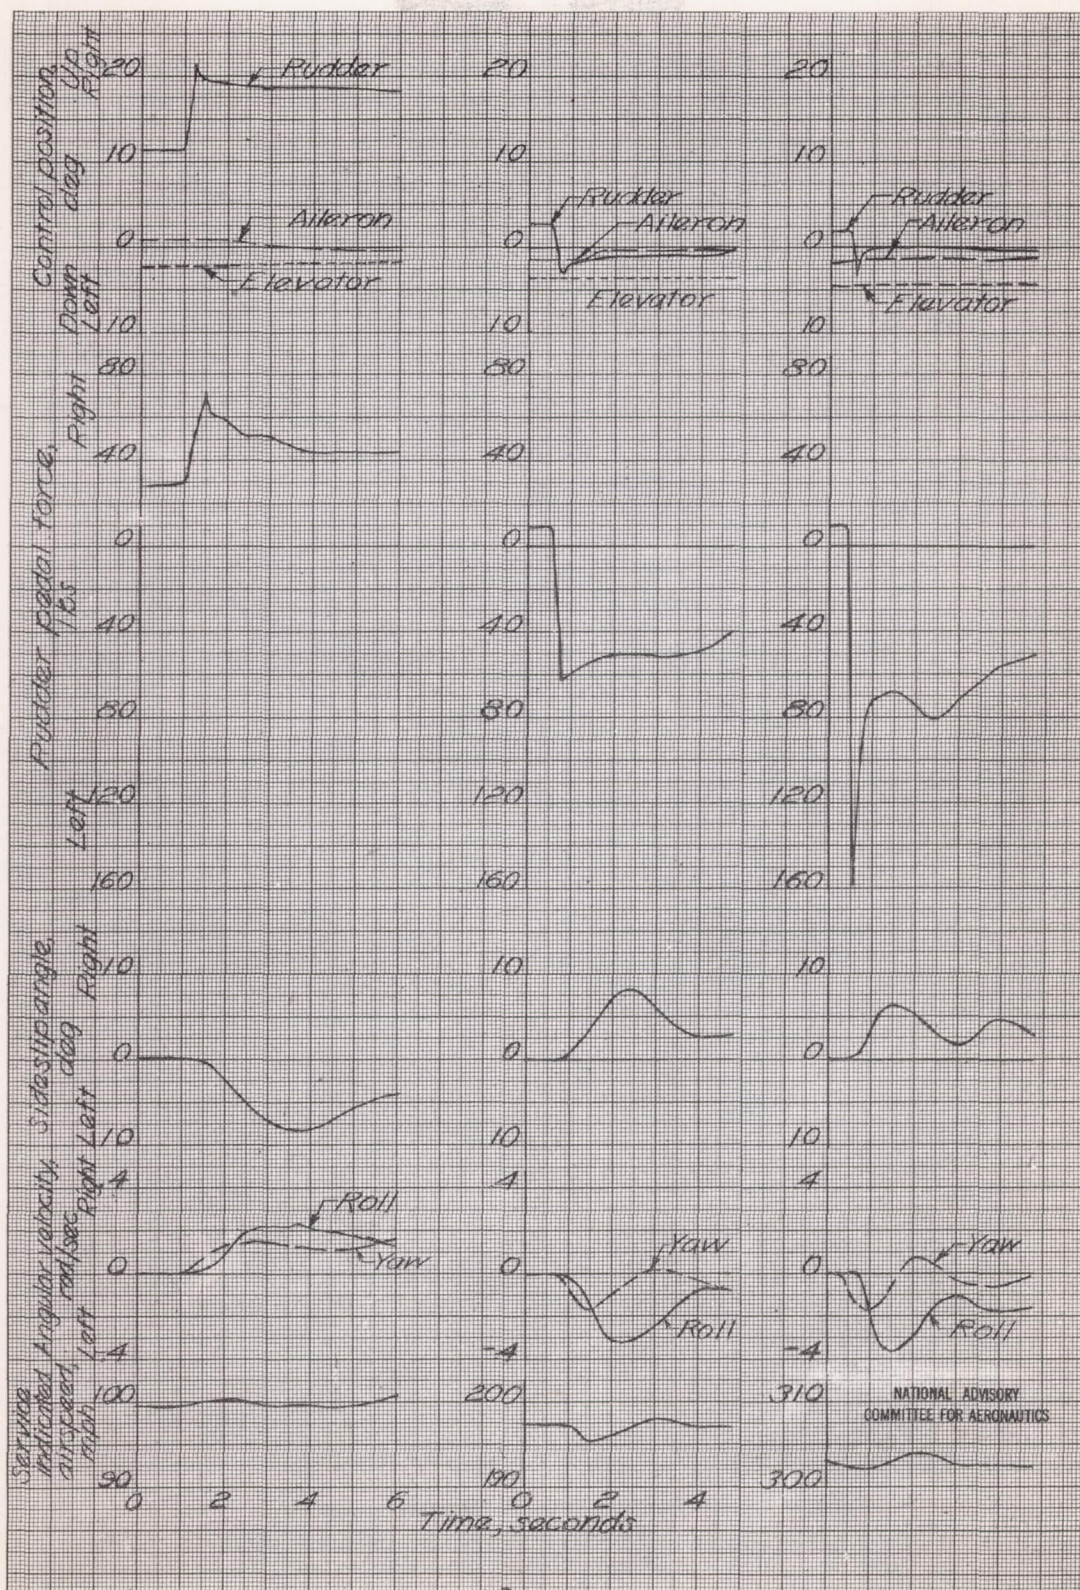
Figure 35. - Typical time histories of abrupt rudder kicks, clean condition, power for level flight, F6F-3 airplane.

The rolling moment due to sideslip was measured in gradually increasing sideslips which were made by slowly deflecting the rudder using the ailerons and elevators to maintain straight flight. A measure of the dihedral effect was obtained from the variation of total aileron angle with sideslip angle. Sideslips were made at various speeds in the landing, wave-off, gliding, and climbing conditions. The data are presented in figures 17 to 30. In these figures rudder, elevator, and aileron forces and deflections and the angle of bank are plotted as functions of sideslip angle. Figures 17 and 18 pertain to the landing condition and data for the wave-off condition are presented in figures 19 and 20. Data for the gliding and climbing condition are shown in figures 21 through 25 and figures 26 through 30, respectively. Additional sideslips were made at a later date in the landing and wave-off condition with control-position recorders installed to measure the landing flap blow-up characteristics. The flaps of the F6F-3 are in four segments which are spring-loaded and blow up independently of each other under aerodynamic loads. A detailed description of this flap arrangement is given in reference 1. During the aforementioned tests the airplane was equipped with an experimental spring tab rudder. The data obtained are shown in figures 31 through 34 where the angle of the four segments of the flaps and the rudder position are plotted as functions of the sideslip angle. Figures 31 and 32 apply to the landing condition and figures 33 and 34 show data for the wave-off condition. Another measure of the dihedral effect was obtained from rudder kicks in which the pilot deflected and held the rudder at a given position, holding the ailerons fixed at trim. Typical time histories of this maneuver are shown

in figure 35. The data obtained were used to determine the variation of maximum yawing and rolling velocity and maximum change in sideslip angle with change in rudder angle. These results are shown in figure 36.

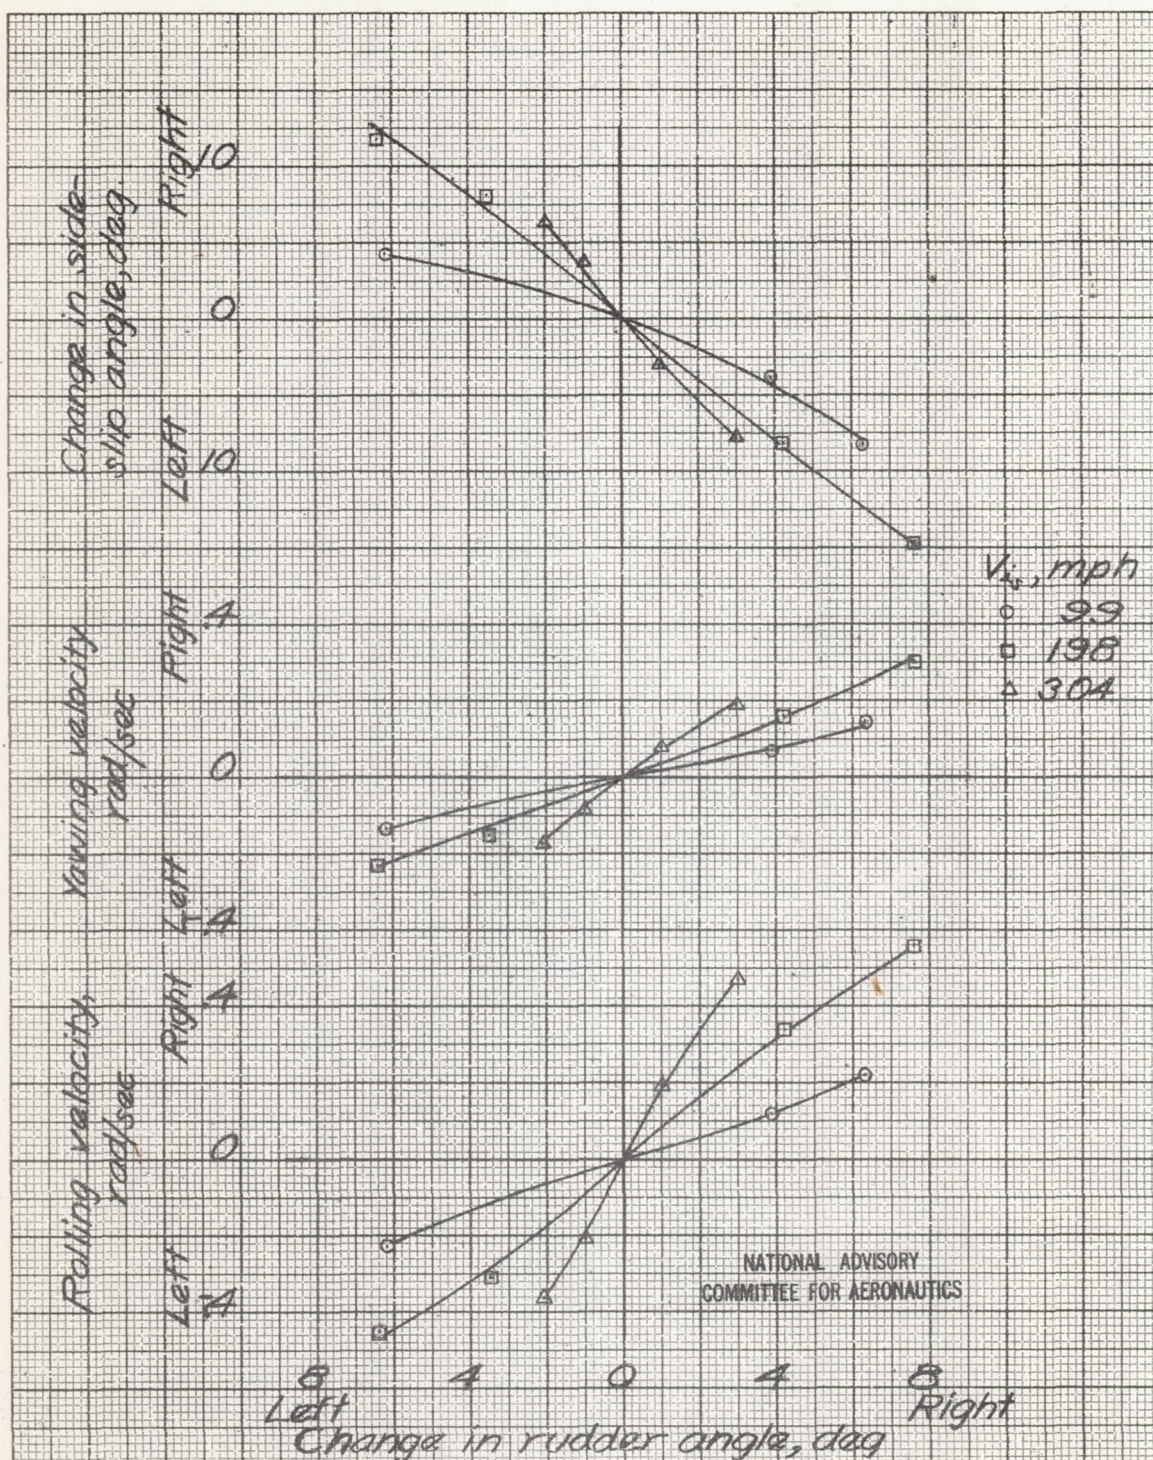
Figure 36. - Variation of maximum sideslip angle, yawing velocity, and rolling velocity with change in rudder angle in abrupt rudder kicks, F6F-3 airplane.
